AEROPRAKT INFORMATION BULLETIN

VIBRATIONS OF THE MAIN LANDING GEAR LEGS OF A-22LS AND A-22L2 AIRPLANES. IB A-22LS-01

MANDATORY

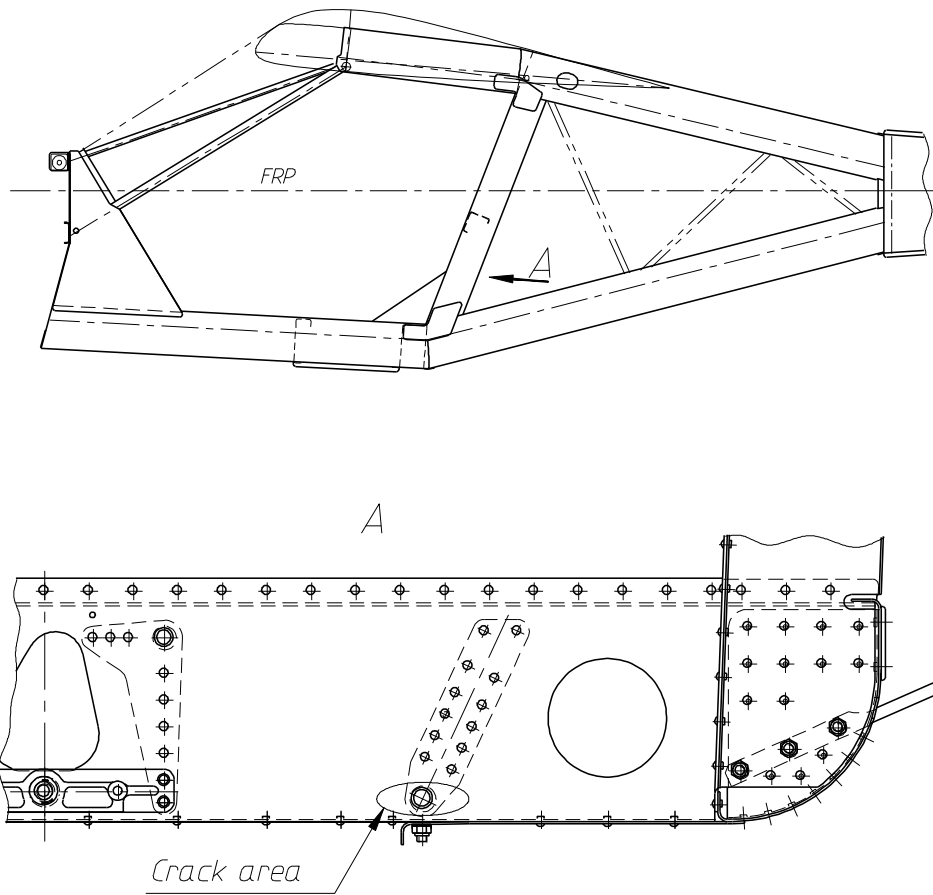
Fig. 1

It was found out that an energetic braking on a hard surface runway causes resonance vibration of the main landing gear legs. The vibrations in their turn cause elastic oscillations of the bottom fuselage skin in the area of the outer lower attachment fitting of the main landing gear leg, which may result in fatigue cracks in the rear web of the transverse beam of the main landing gear attachment. To reduce the probability of crack creation it is necessary to increase the stiffness of fuselage skin in the area of the attachment fittings of the main landing gear using the reinforcing angles. **It is strongly recommended to avoid the resonance vibrations of the main landing gear.**

1. Inspect the beam for cracks in the specified (see fig. 1).

◆ **NOTE:** The beam must be inspected on the sides of both left and right landing gear leg, regardless the fact that the figure below shows only the right leg.

If cracks are found it is necessary to perform the repair work according to p. 3.1.2, otherwise carry out inspection regularly.
