# **AEROPRAKT SERVICE BULLETIN**

**№ SB A22LS-22**

## **INCREASE OF WATER PUMP SCREW-CLAMP TORQUE OF A22LS AND A22L2 AIRCRAFT**

**Model: A22LS and A22L2**

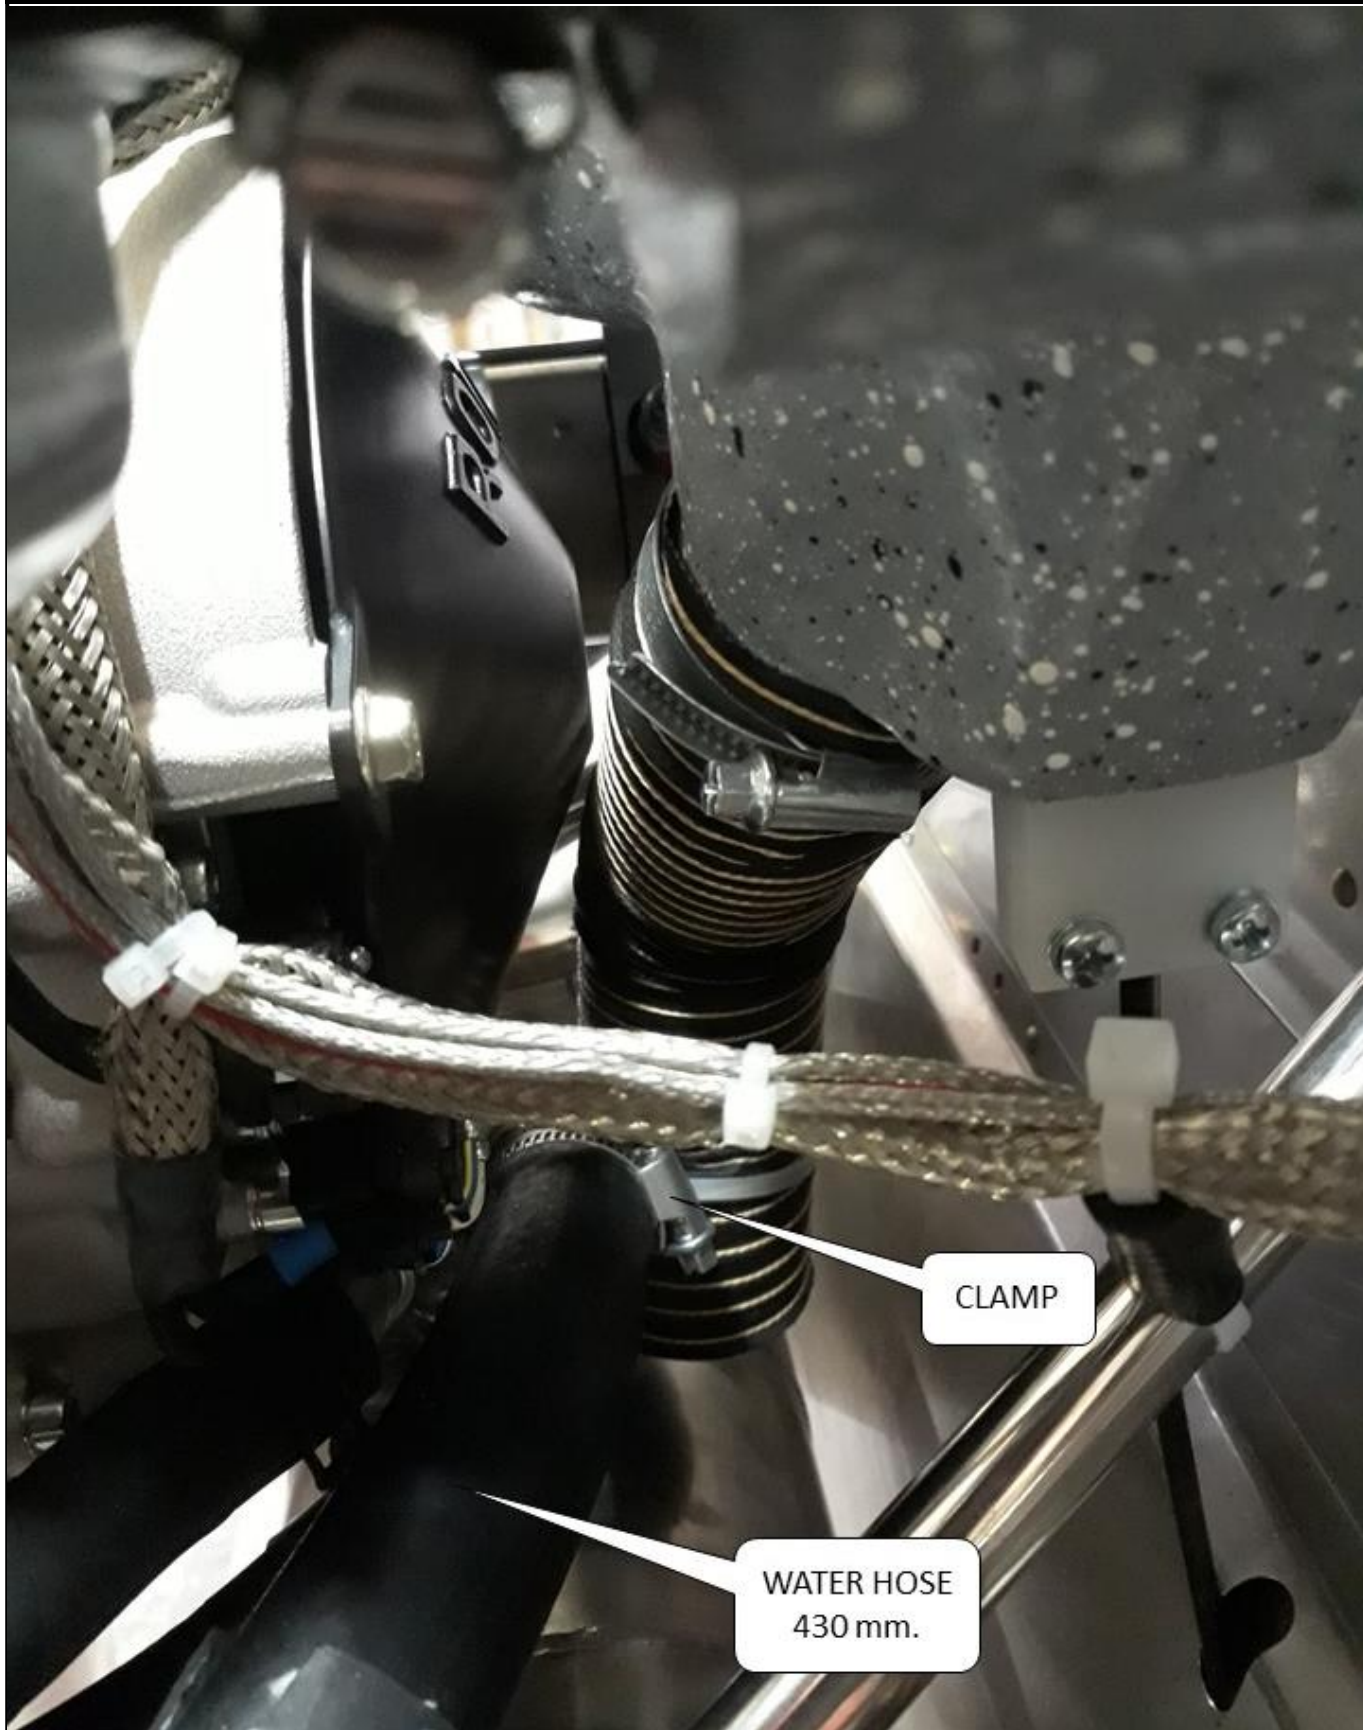
Due to change of the water hose properties by the hose manufacturer the water hose attached to the inlet of the water pump may disconnect in operation (see photo 1).

Screw-clamp attaching the water hose on the engine cooling system water pump inlet. See photo 1.

- in the “INSPECTION CHART” table add a line for the first inspection of the screw-clamp after 25 hours and every 100 hours for the following inspections;
- add instruction: “When inspecting the screw-clamp attaching the water hose to the water pump inlet make sure its tightening torque is equal to 4 N·m (3 lb·ft).

- 3.1) Remove the upper and lower cowling panels.
- 3.2) Tighten the screw-clamp shown in Photo 1 to 4 N·m (3 lb·ft) torque.
- 3.3) Put back the upper and lower cowling panels.
