AEROPRAKT

INFORMATION BULLETIN

REPLACEMENT OF THE DOOR AIR SCOOPS OF A-22 AIRCRAFT

IB A-22-07

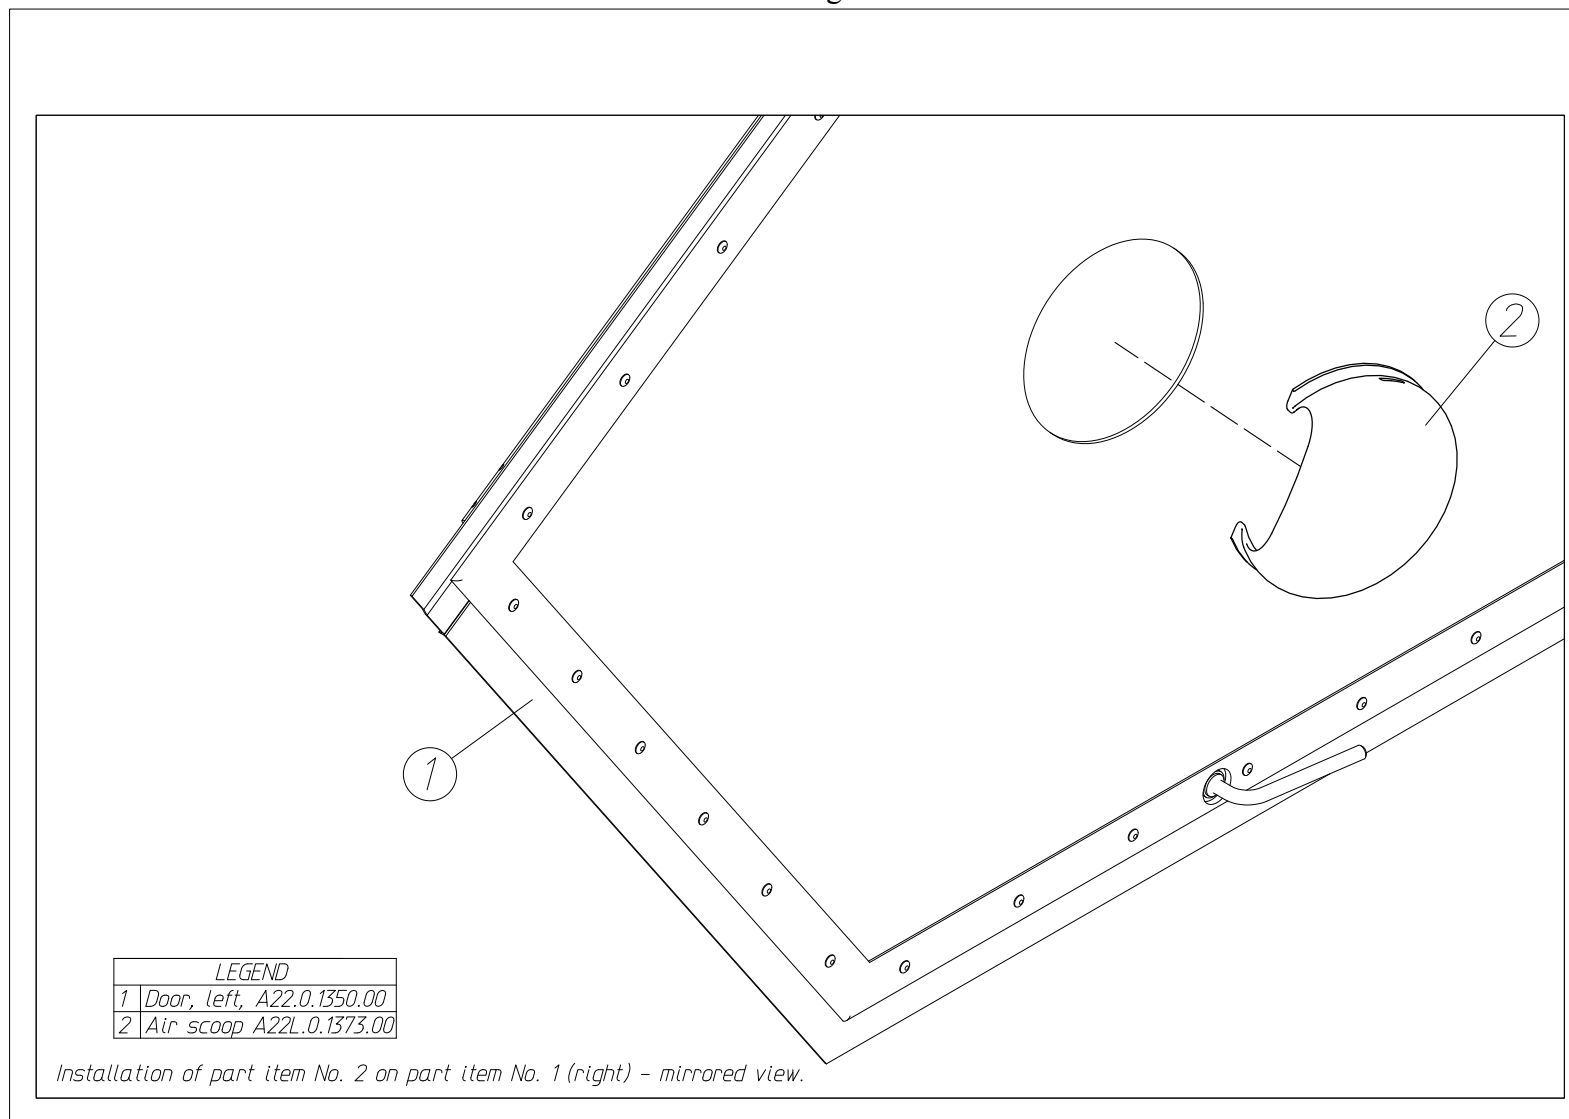
Fig. 1

The air scoop has the shape of a lens which focuses the direct sun light and causes melting of the seat cushions and floor rugs.

- 1) Remove the old air scoop.
- 2) Squeeze the new air scoop (2) by hand and install it in the place of the old one.
- 3) Install the scoop handle (3).

◆ **NOTE:** The air scoop must be installed from outside and the scoop handle – from inside.

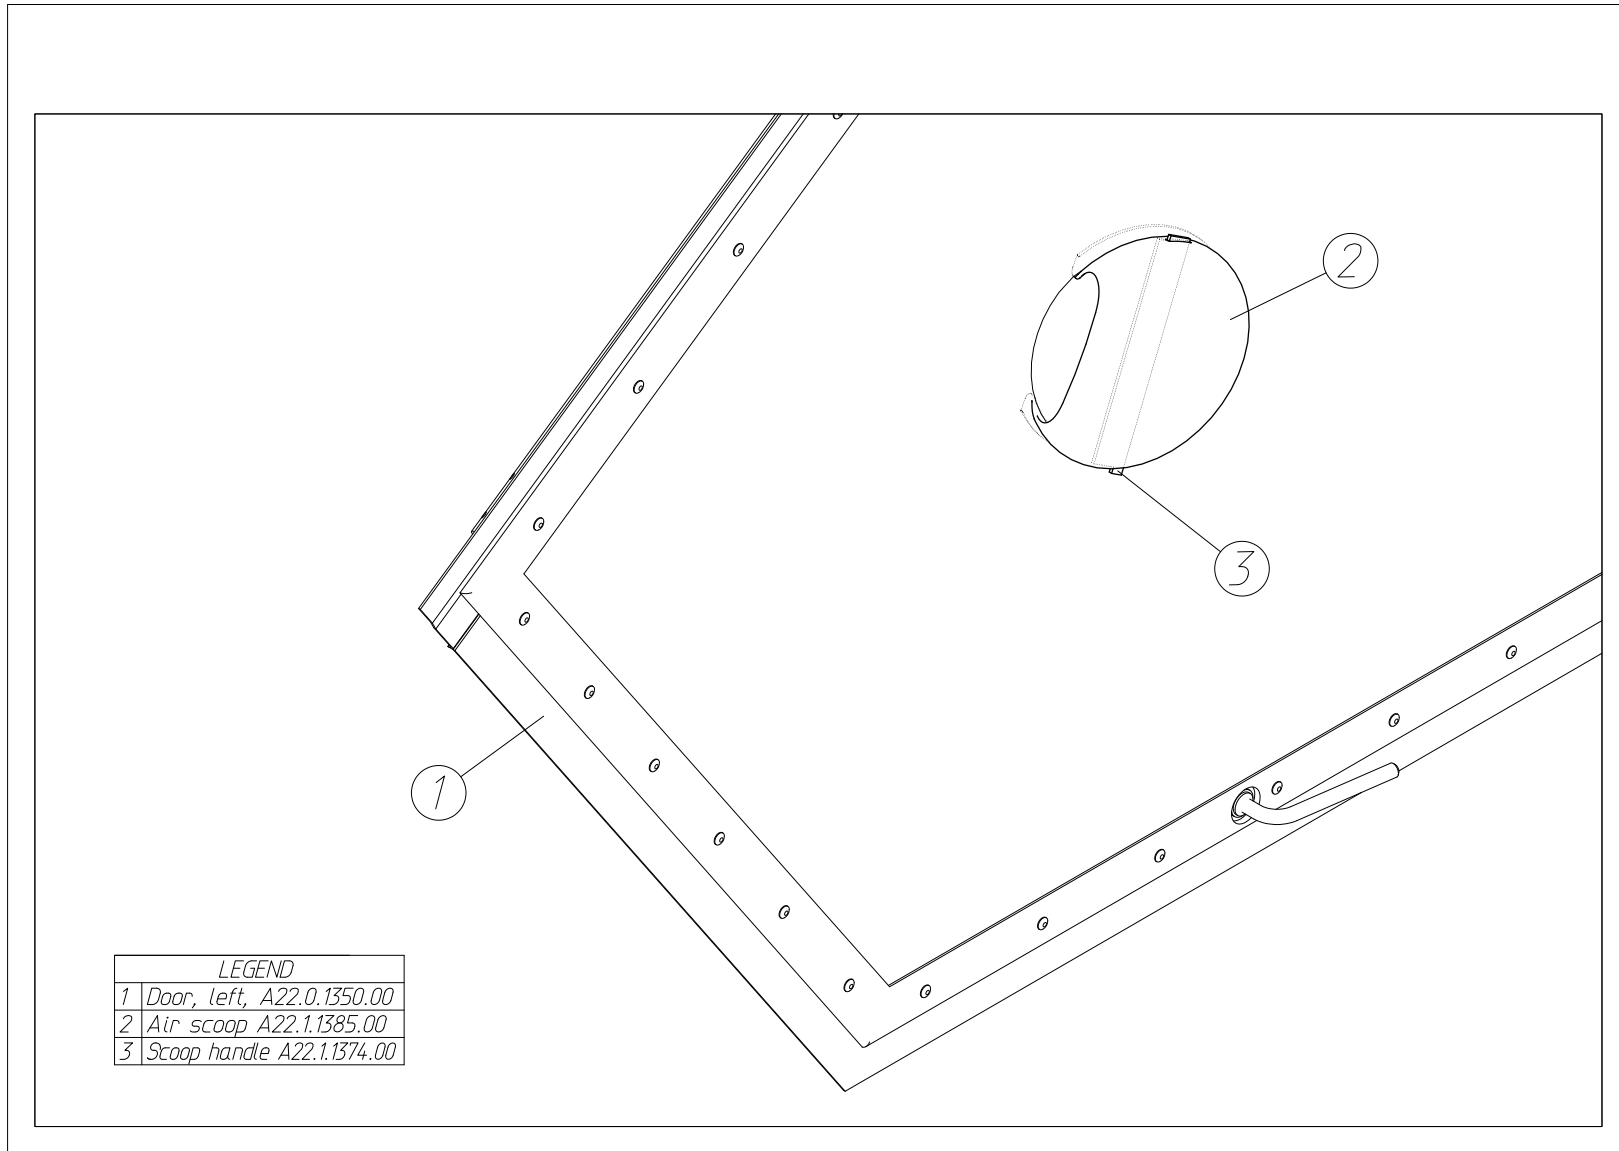
Fig. 2

▲ **WARNING:** In cloudless weather the sun rays, passing through the air scoop, can melt the material of the seat cushions and floor rugs. In the new air scoops this effect is excluded due to the uniform glass thickness over the surface of the air scoop.
