# **AEROPRAKT SERVICE BULLETIN**

**No. SB A32-05**

## **REINFORCEMENT OF THE FRAME No.10 OF A32 AND A32L AIRCRAFT**

**Model: A32, A32L**

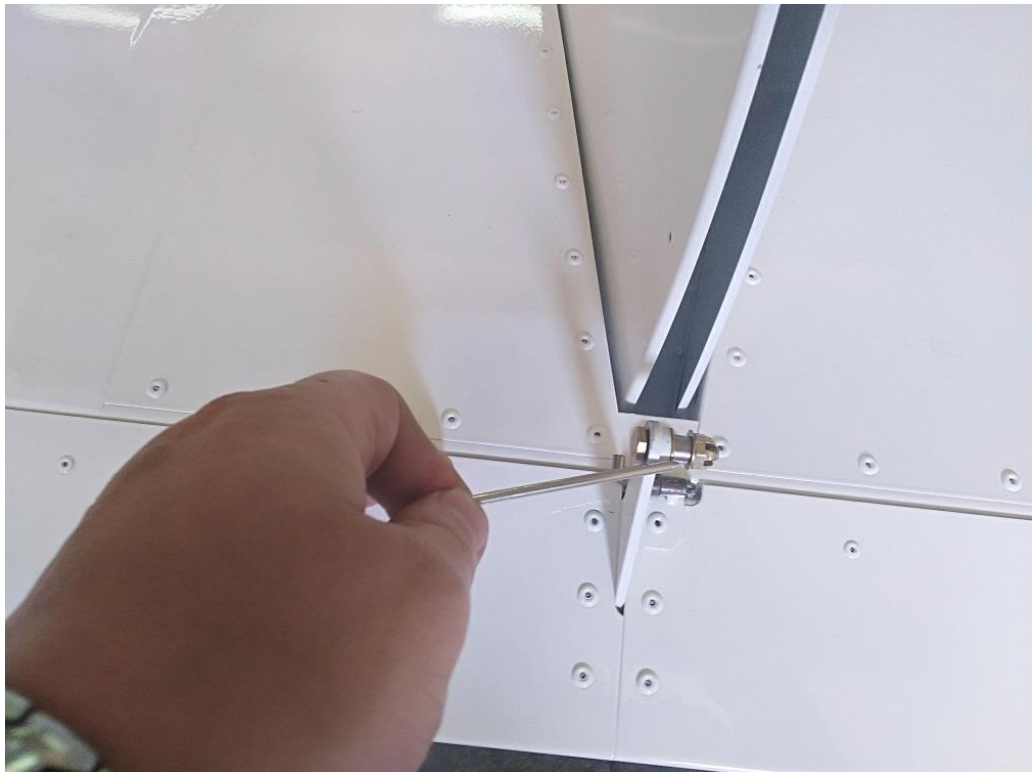
**Fig. 2.**

3.2) Disconnect the AMHT (all-moving horizontal tail) antiservo/trim tab control cable (Fig.2).

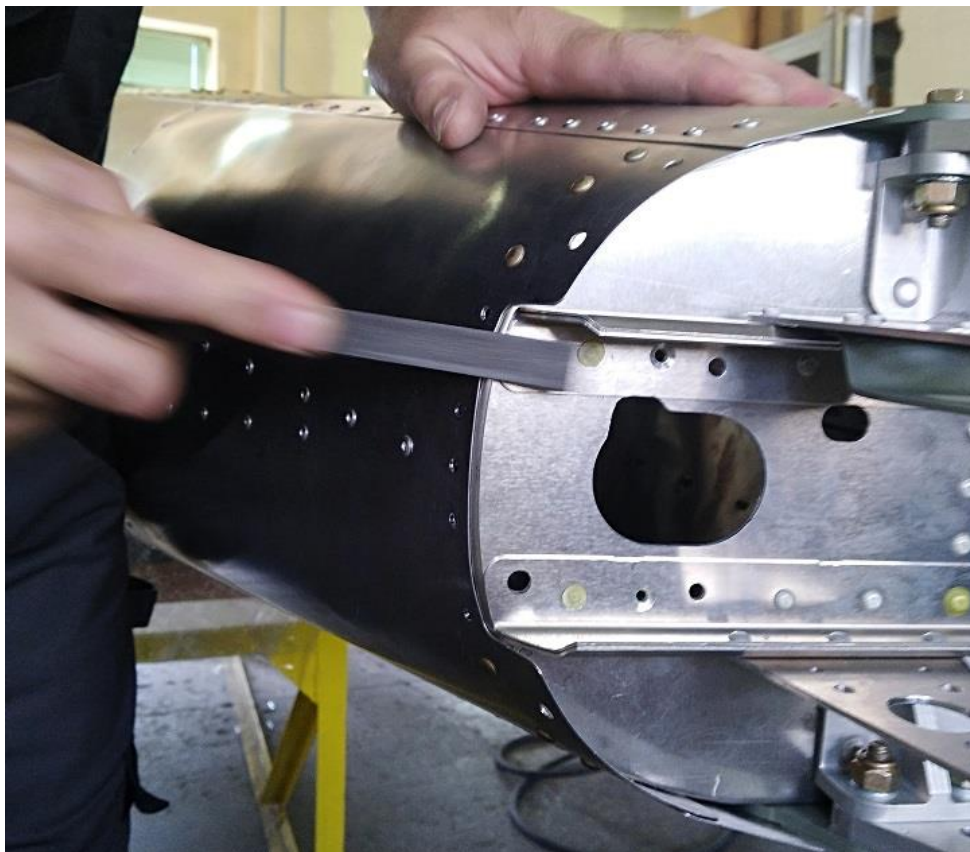
**Fig. 10.**

3.10) Round the sharp edge of the fin spar flange to ensure a better fit of the doubler (Fig. 10).

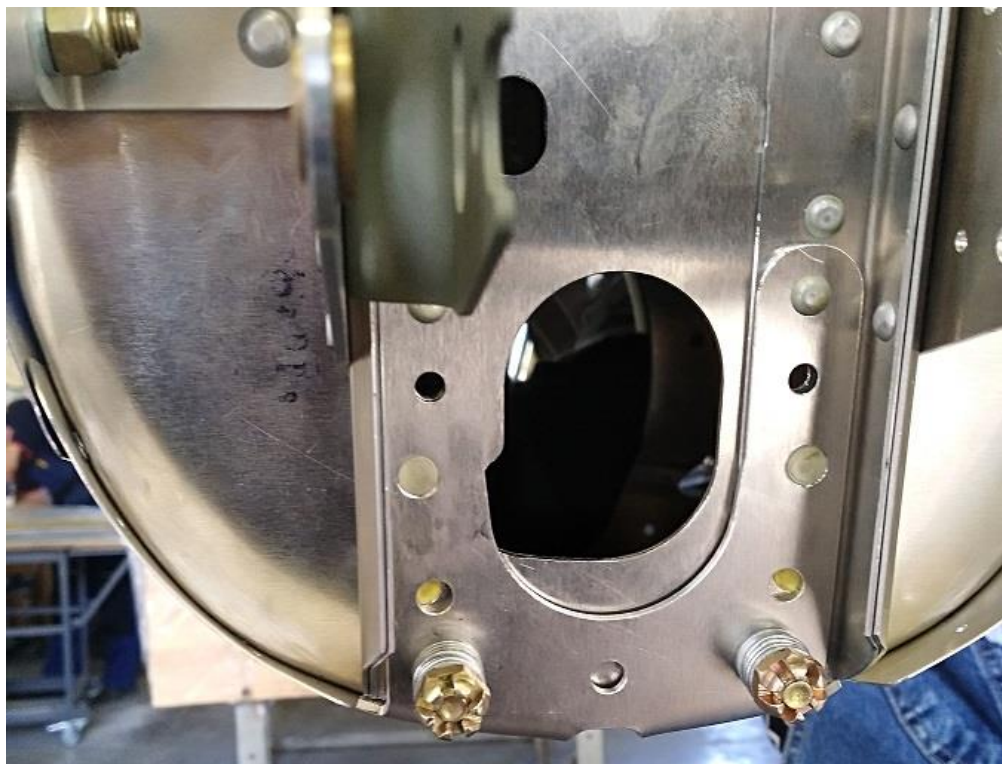
**Fig. 11.**

3.11) Attach the doubler with temporary bolts, install two rivets with flush heads and two rivets with normal heads on the fin spar (Fig. 11).
